GE Document No. 77SDR2181

# AN EXPERIMENT TO CORRELATE STRUMMING AND FISHBITE EVENTS ON DEEP OCEAN MOORINGS

Eric J. Softley  
John F. Dilley  
David A. Rogers

May, 1977

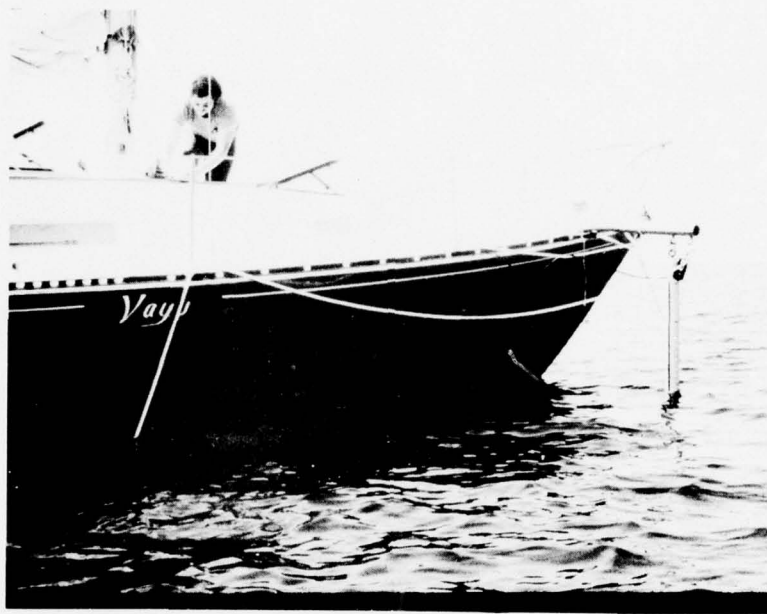
Figure 8. "VAYU" With Strumming Sensor Attached At Bow

In May of 1976, a location in the Chesapeake Bay was chosen to evaluate the strumming sensor and the performance of the anti-strumming fairing. The experiment was performed aboard a 35 ft. sailing auxiliary, see Figure 8. The location was south of the Annapolis Bay Bridge, see Figure 9. The ship was anchored in 130 feet of water. Two 100 ft. cables were used for the strumming measurements; one faired and the second unfaired. These were attached to a 500 lb. anchor along with a nylon anchor crown line. The crown line and the cable not being tested were allowed to drift downstream, supported by small surface floats, see Figure 10. Current measurements were taken using both a prop-type and an inclinometer type currentmeters.

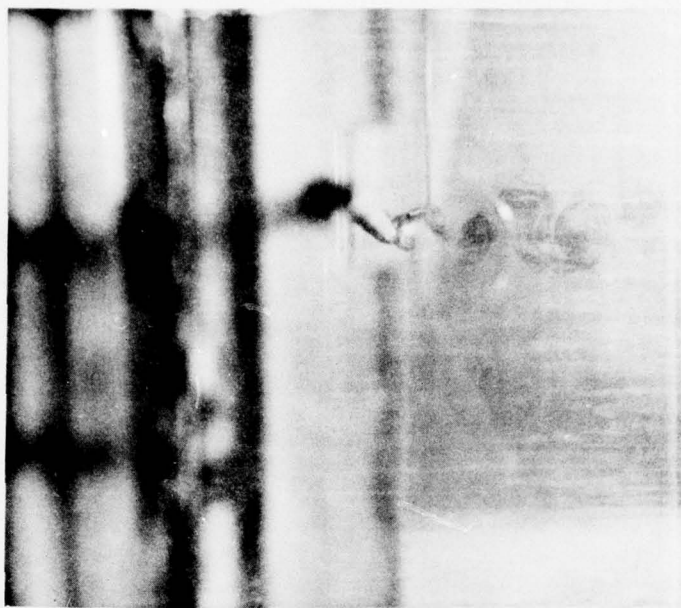
Figure 22. Water Tunnel Test Of Anti-Strumming Fairing

To get additional data on the effectiveness of our anti-strumming fairing, a water channel was used to observe the flows.

a. Vortex Shedding from Bare Tubing

b. Turbulent Wake from Tubing with Anti-Strumming Fairings Attached

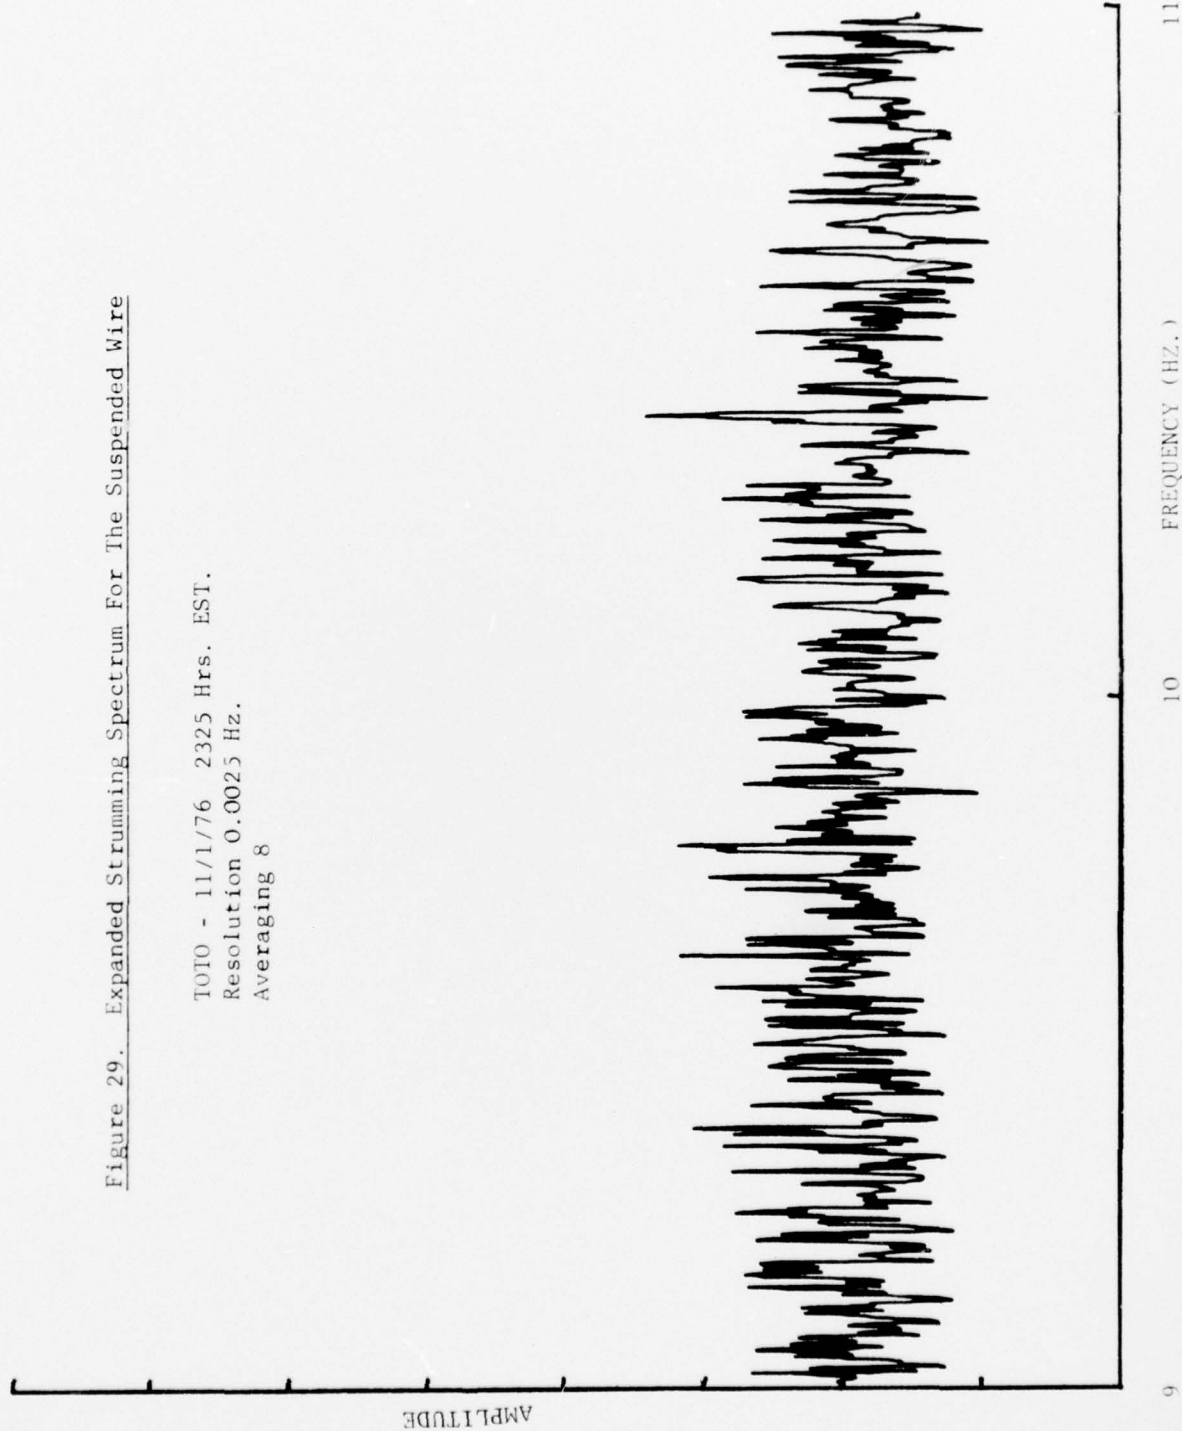
Figure 29. Expanded Strumming Spectrum For The Suspended Wire

TOTO - 11/1/76 2325 Hrs. EST.  
Resolution 0.0025 Hz.  
Averaging 8
